# New York State Department of Transportation

## Yellow Flag NB2228W006

**BIN: 1065318**

Location: Span 187, Girder G1 at Pier 187.

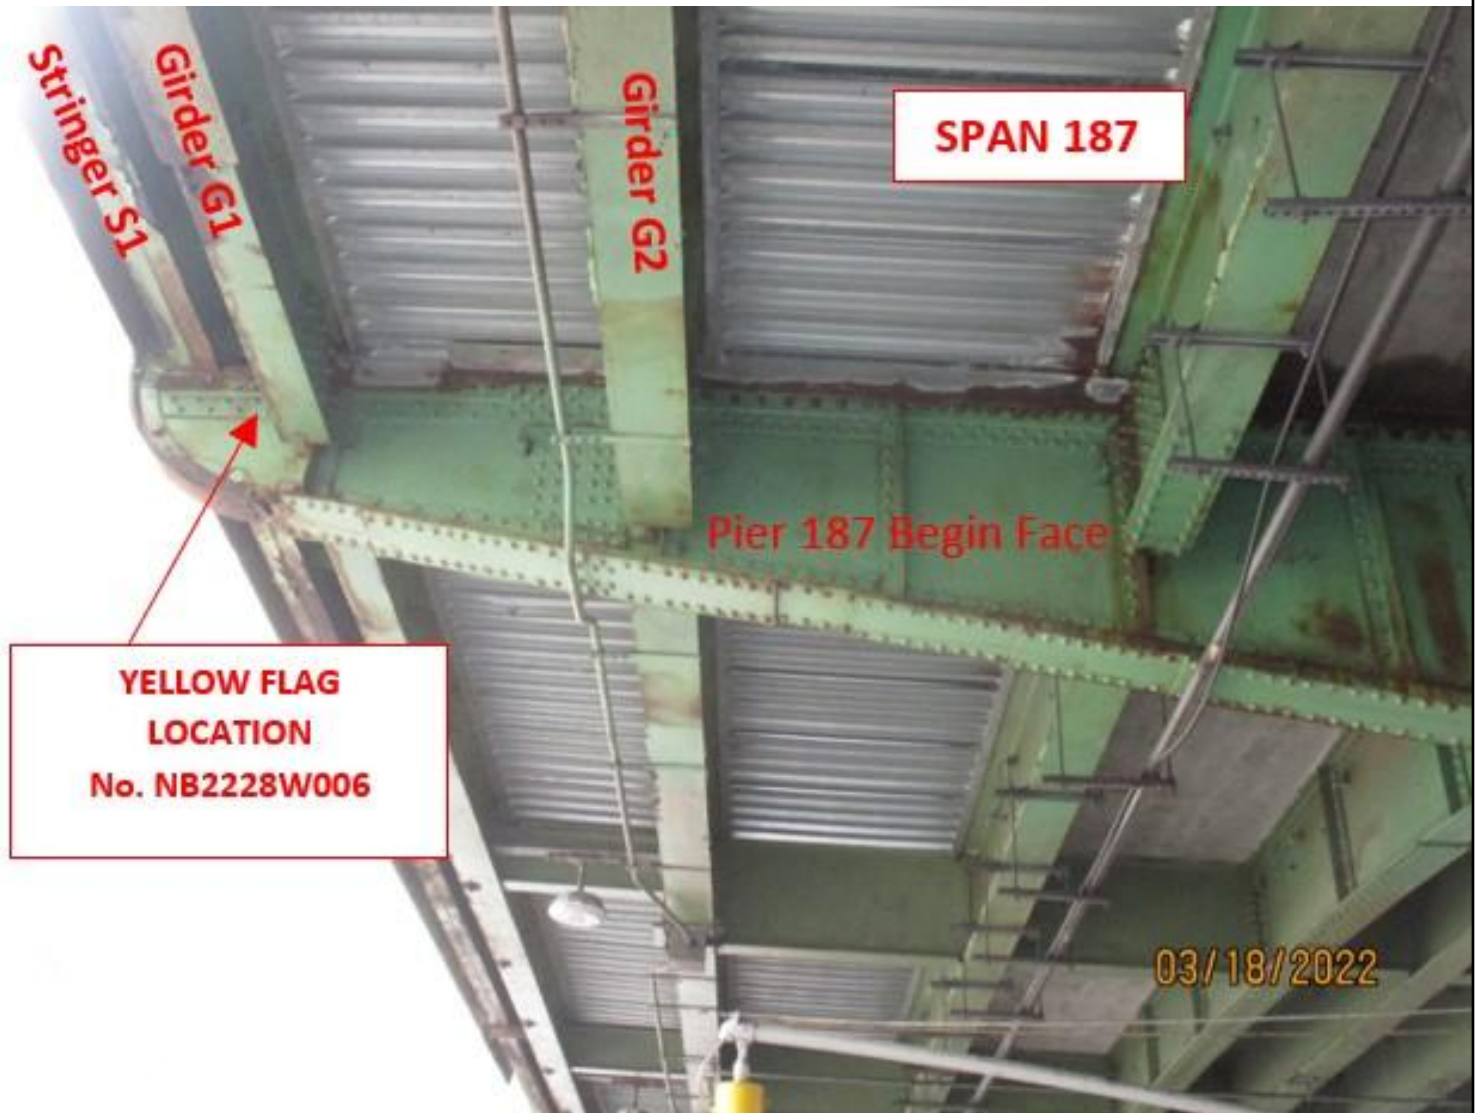
Photo Number: 1

**Attachment Description:** Span 187, Girder G1 at Pier 187. General view of flagged location at pier cap connection. Looking end.

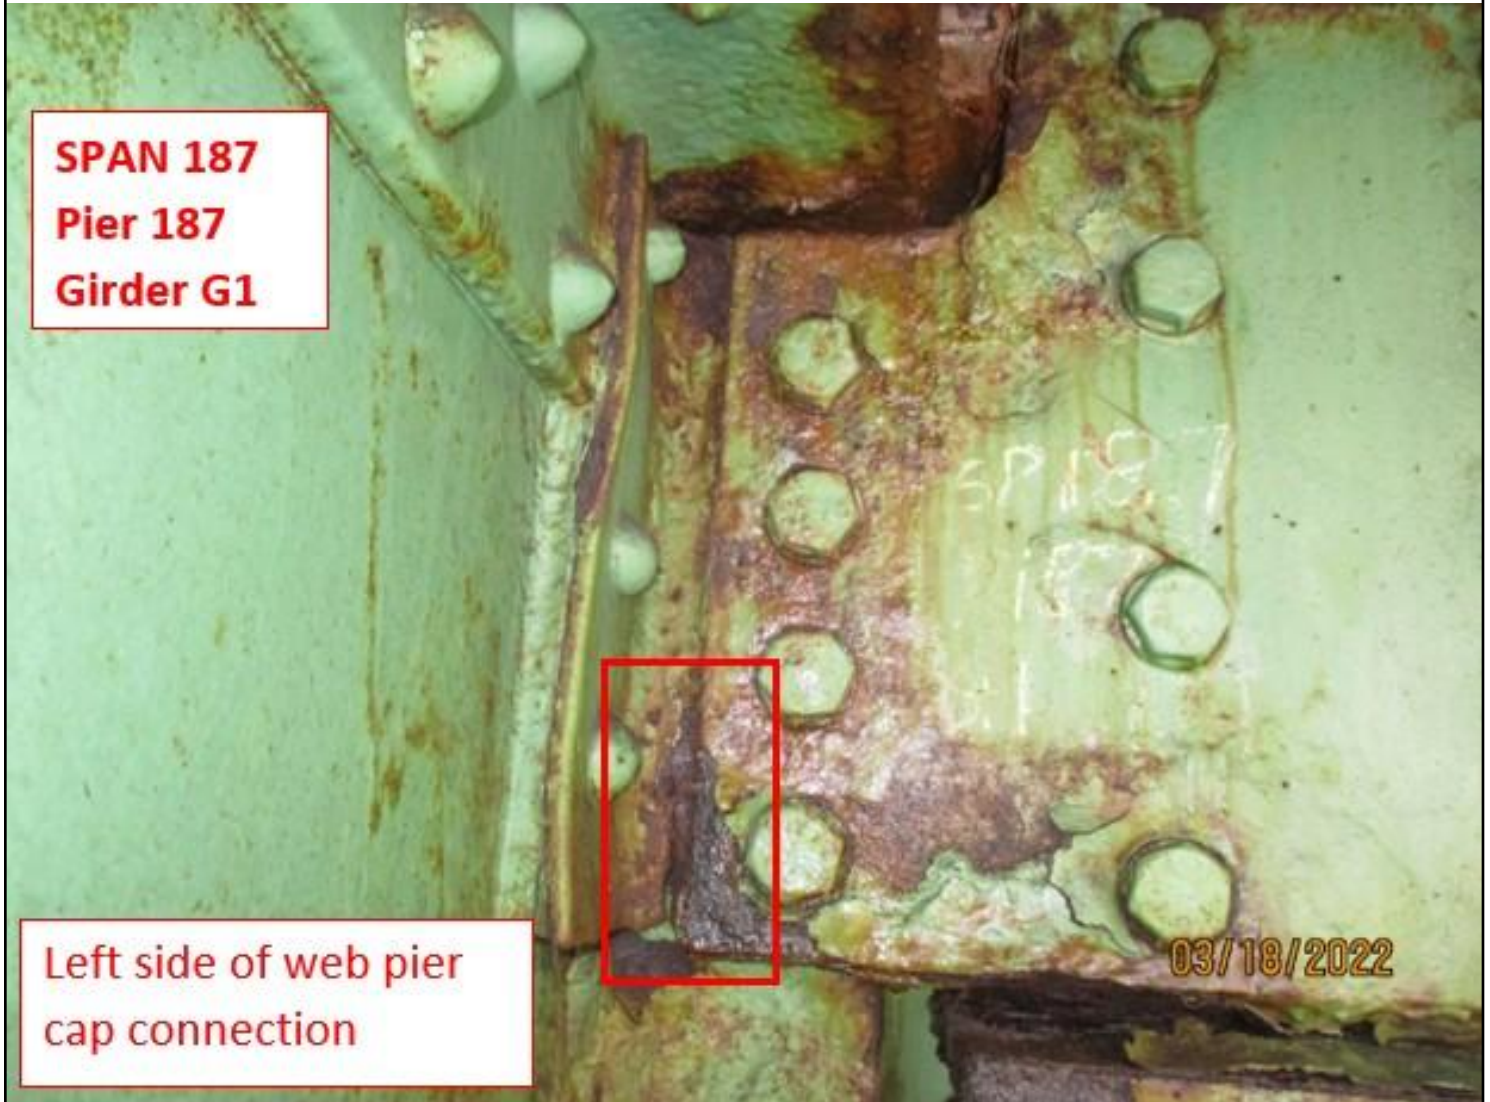
Photo Number: 2

Description: The left clip/connection angle of Girder G1 connection to the pier cap at Pier 187 exhibits a 2-3/4" long vertical crack x 1/4" wide at the lower fillet section (deterioration induced cracking, no change from the previous).

**Attachment Description:** Span 187, Girder G1 at Pier 187. General view of 2.75" long crack at lower fillet of clip connection angle at left side of web at pier cap connection. Looking right.

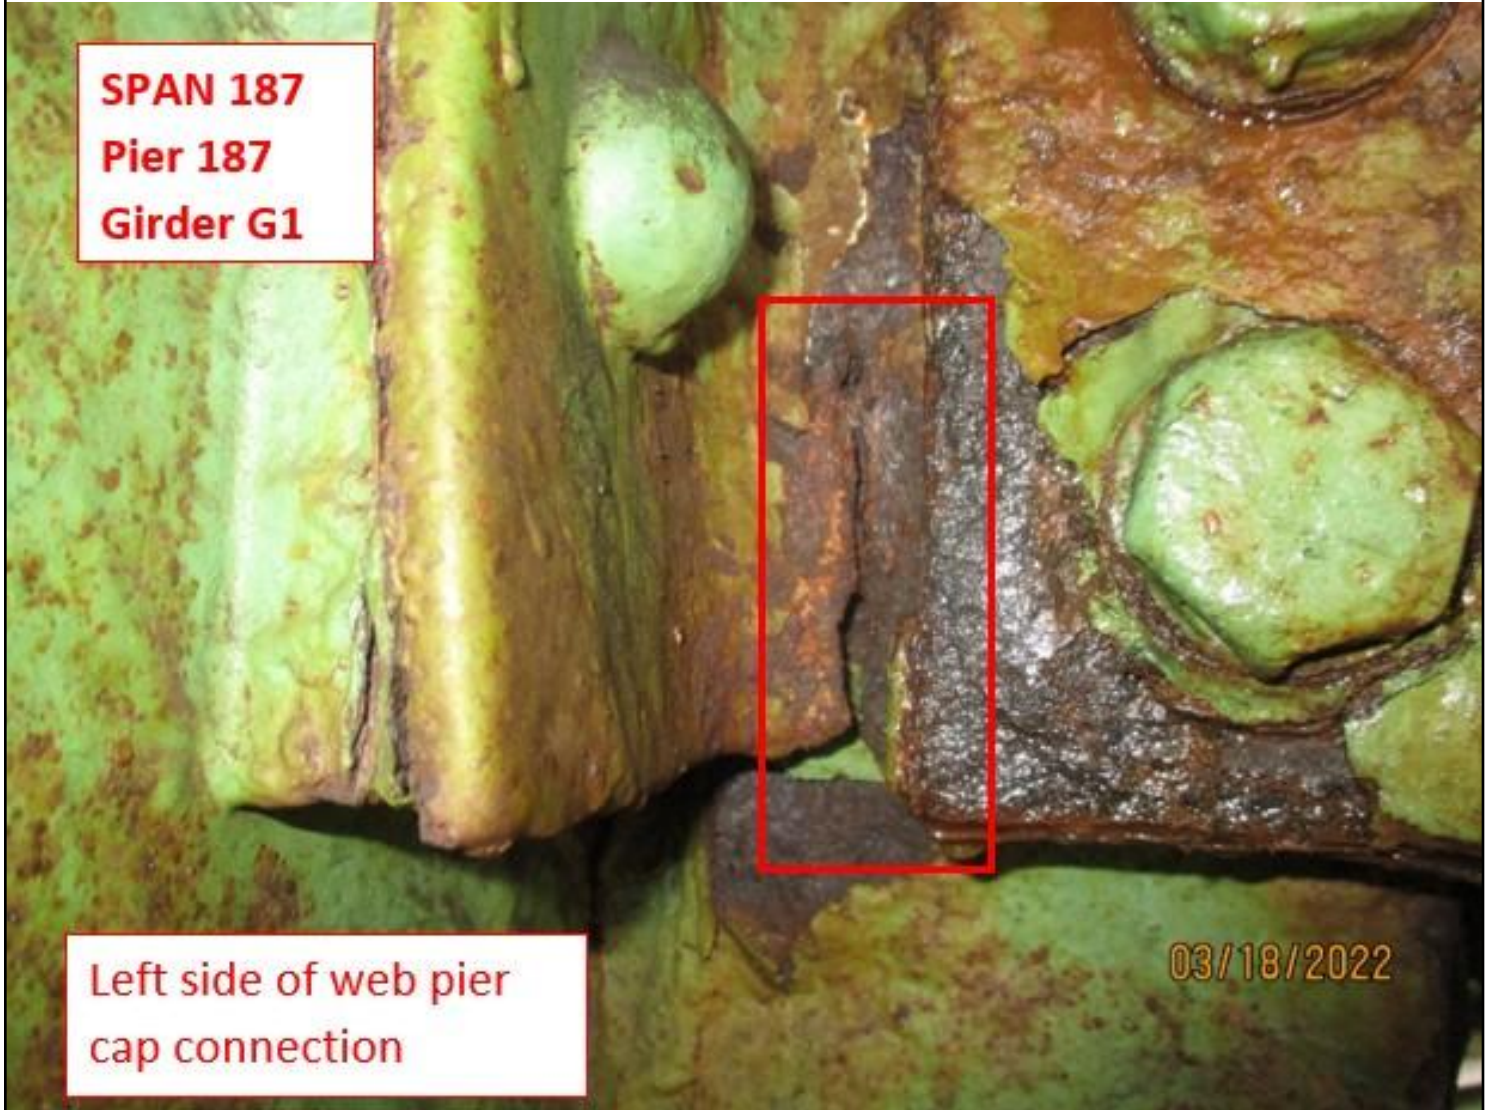
Photo Number: 4

**Attachment Description:** Span 187, Girder G1 at Pier 187. Close up view of 2.75" long x 1/4" wide corrosion crack at lower fillet of clip connection angle at left side of web at pier cap connection. Looking right.

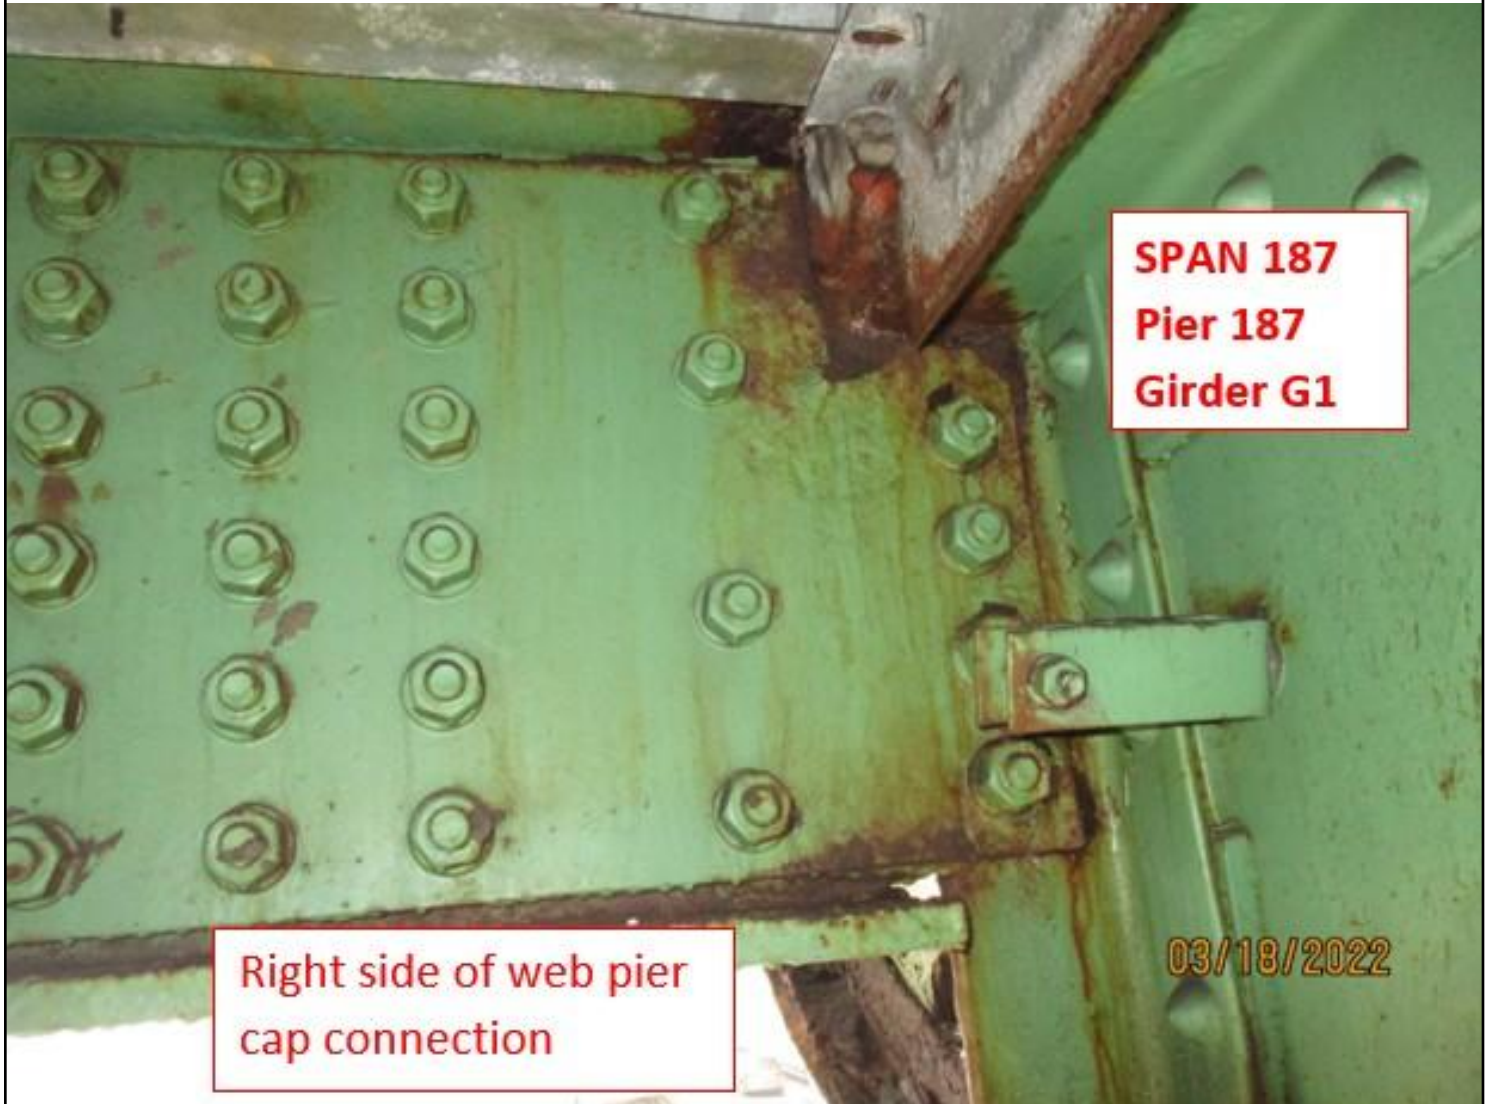
**Attachment Description:** Span 187, Girder G1 at Pier 187. General view of stiffener connection angle in good condition at right side of web at pier cap connection. Looking left.
